Follow Safe Practices!!

A-Frame LADDER

LADDER

# Preface

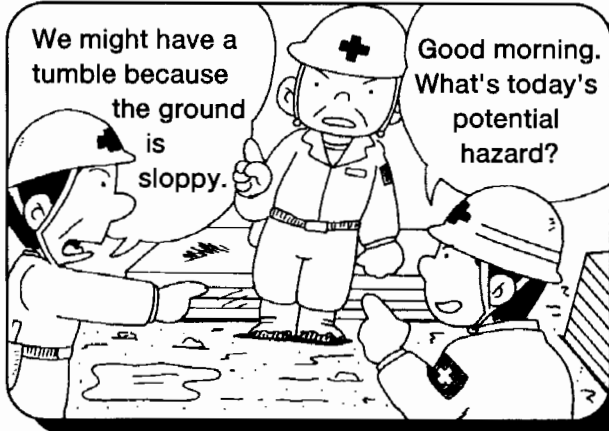
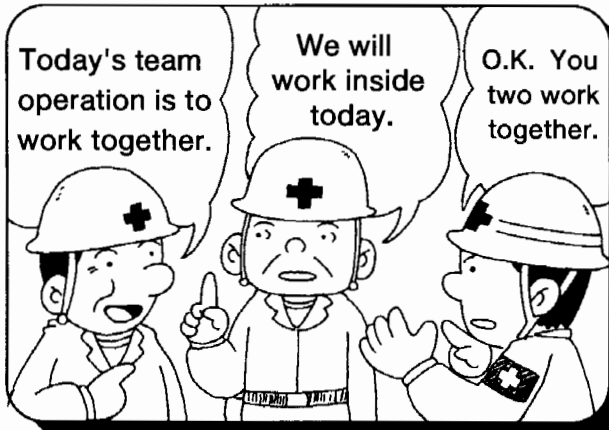
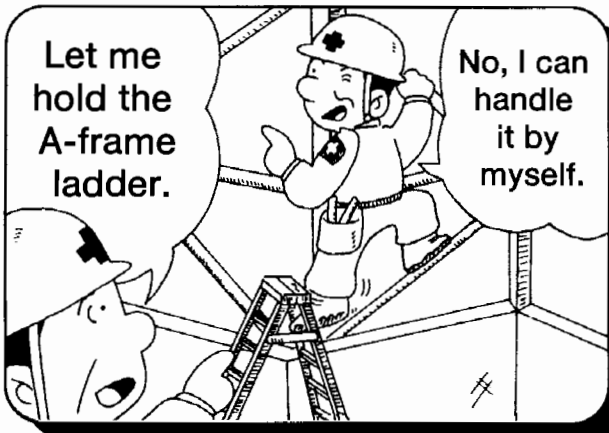
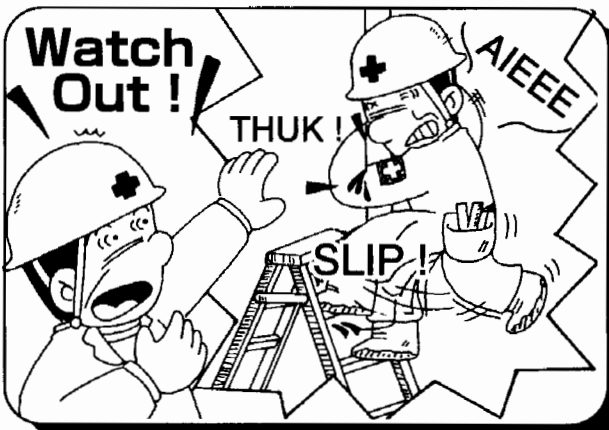
In Spite of a Risk Prediction (PR)

Monday, May 22  
 At around 2:30 P.M.  
 Fine in weather (rainy yesterday)  
 41 years old  
 Exterior Assembler  
 14 years' experience

Risk Prediction (RP) was done.  
 The two were assigned to work in pairs

He was working alone on the A-frame ladder.

He slipped and got off balance. He instinctively held tight the corner frame, and was stabbed deep on his left arm.  
 LWD (Lost Work Days) : 30 days

On Monday, May 22 (at about 2:30 P.M.), he was working on a A-frame ladder in the corner to frame the 1st floor of a two-storied house.

The instruction on pair work inside the house was delivered during a briefing in the morning because the ground remained sloppy from rain on the previous day, although it was fine on the incident day.

In spite of the instruction, he worked alone, and his muddy shoes caused him to slip. He lost his balance and instinctively held tight the corner frame. He received a cut on his left arm. He was given a diagnosis of an open wound on the left forearm and obliged to take 30 days off.

- 1 Work in pairs
- 2 Perform the risk prediction. Clear the mud off the shoes before setting to work.
- 3 Encourage workers to keep safety awareness in mind.

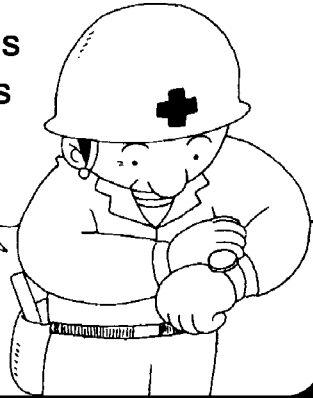
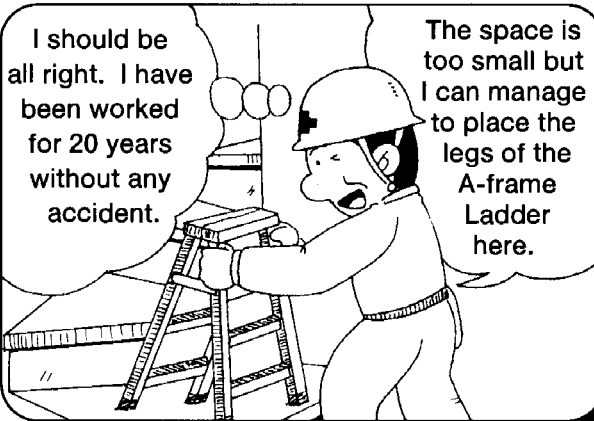
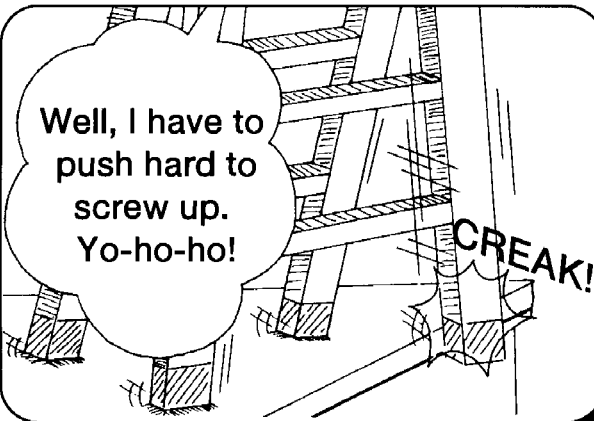
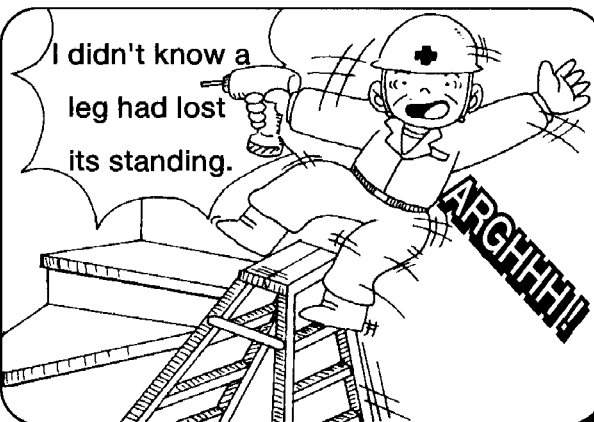
Even a person with 20-year experience

Tuesday, October 3  
At 5:10 P.M.

Fine in weather  
41 years old Carpenter  
22 years and 6 months' experience

He set the A-frame ladder on the small stair landing near the low-lying entrance.

When he pushed against the board to screw up, the A-frame ladder moved. He did not aware of it.

When he climbed down, the A-frame ladder shook. He lost his balance and fell down on the floor. He had his haunch bone fractured

LWD: 30 days.

At around 5:10 P.M., on Tuesday, October 3, Mr. F, a carpenter with more than 20 years' experience was working on screwing up to fix wall boards on a A-frame ladder placed near the side of the low-lying entrance of a house. During this work, he did not pay careful attention to the position of the A-frame ladder.

When he pushed hard against a board, the A-frame ladder got off to the side. He was unaware of this, and tried to get down from the A-frame ladder. They wobbled and he fell down to the floor, losing his balance.

He bumped his back hard against the floor and had his haunch bone fractured. He could not work for about 1 month.

- 1 Confirm that the enough space is secured for setting a A-frame ladder.
- 2 At a place where safe space is not available, a temporary scaffold should be installed.
- 3 Use a A-frame ladder with flexible legs. Set the A-frame ladder with two of the legs on the first step of the staircase. Keep it close to the working object and away from the low-lying entrance.
- 4 Encourage workers to keep safety awareness in mind.
- 5 Carry out the promotion of the risk prediction.

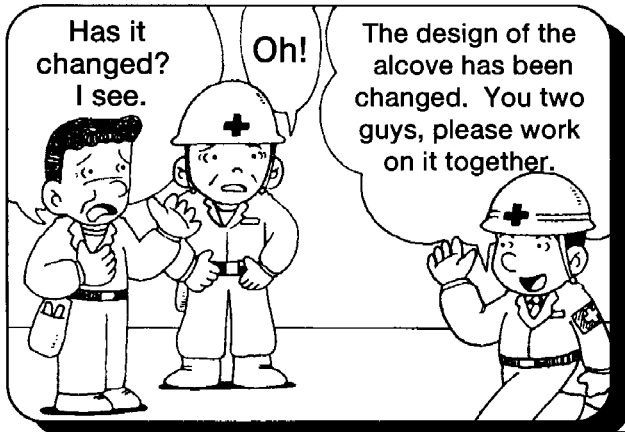
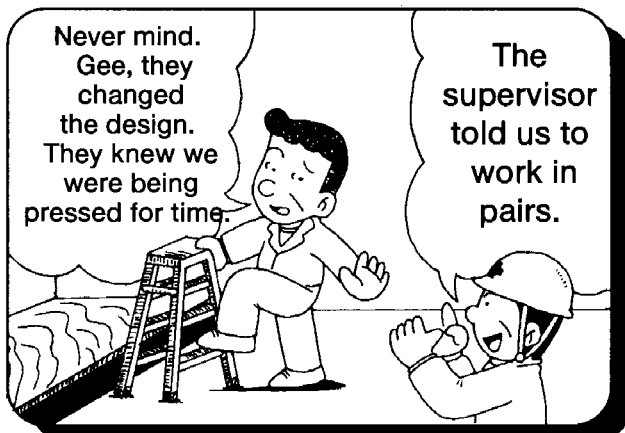
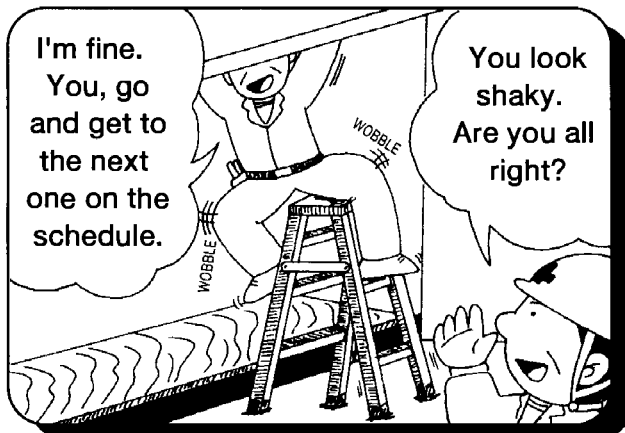
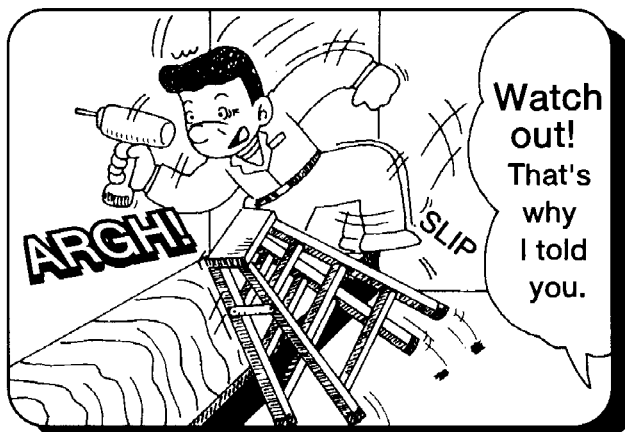
Hasty Work Needs Extra Care

Saturday, April 15  
 At around 10:00 A.M.  
 Fine in weather  
 47 years old Carpenter  
 20 years' experience

He set to work on the change in the alcove without his partner's help.

The A-frame ladder could not be placed in the right place due to the platform in the alcove. He had to work at full stretch toward the ceiling.

He slipped and fell down with the A-frame ladder, losing his balance. He had his rib bone broken.  
 LWD: 20 days.

Mr. A, a carpenter, was a member of the team for the interior construction of a two-storied house. At around 10 A.M. on Saturday, April 15, he started working on the alcove by himself. Earlier in the morning, his supervisor told him to work on the design change of the alcove with the carpenter B. He, however, let his partner proceed to the next process, considering the work schedule.

He was engaged in the design change on the ceiling of the alcove, standing on a A-frame ladder, which was not placed in a proper position due to the platform in the alcove. When he stretched out to the ceiling, he slipped and lost his balance. He fell down together with the A-frame ladder. He bumped his chest against the A-frame ladder and had his rib bone fractured. He could not work for 20 days.

- ① Lay a board of 12 mm in thickness on the platform of the alcove and then place a A-frame ladder, so that the surface of the platform is not damaged.
- ② Use not one but correctly designed A-frame ladders (two-point support).
- ③ Work in pairs. (Never work alone)
- ④ Follow instructions by a field supervisor.
- ⑤ Confirm safety before work.

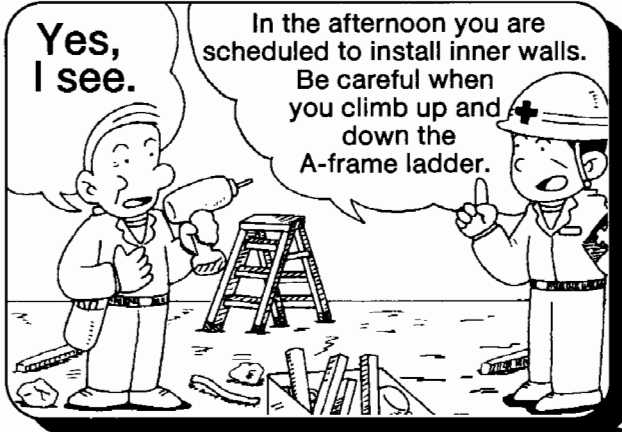
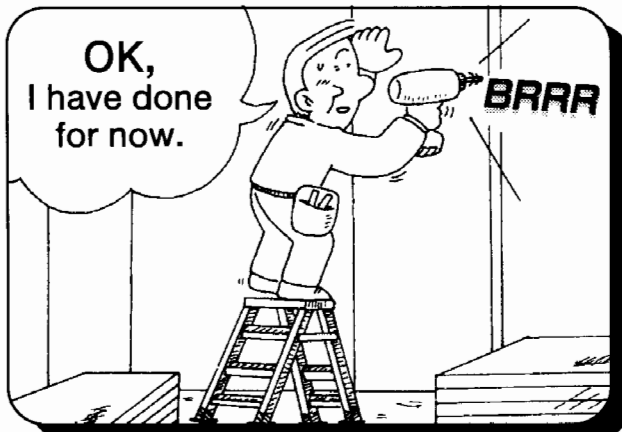
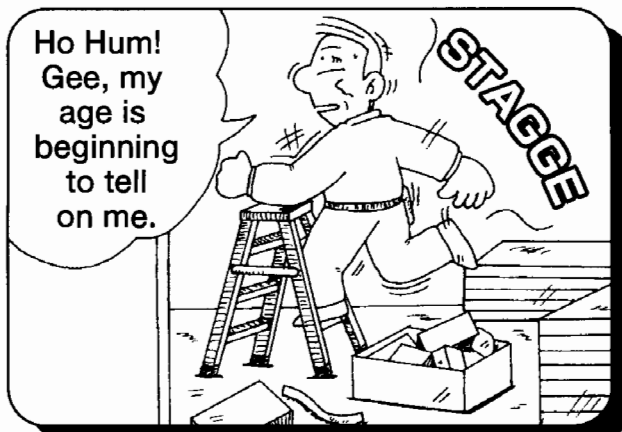
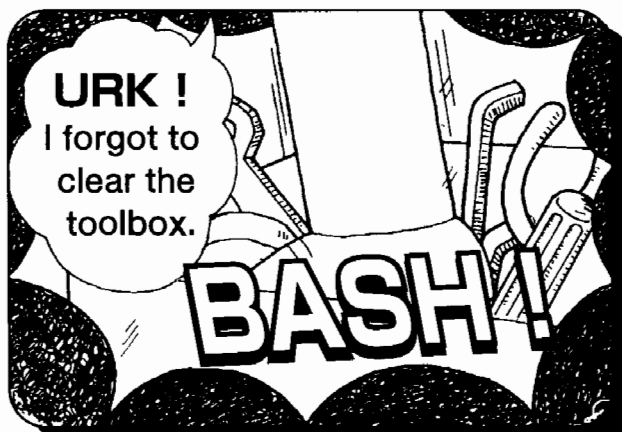
Monday, February 27  
 At around 2 P.M.  
 Cloudy in weather  
 65 years old    Assis-  
 tant carpenter  
 15 years and 2 months  
 in experience

Mr. H, who is an aged  
 worker, finished the  
 immediate portion of  
 his assignment and was  
 getting down the A-frame  
 ladder.

When he just put his  
 left foot on the second  
 step, he lost his bal-  
 ance.

He jumped off on the  
 right leg and crushed  
 into the toolbox. He  
 had the joint of his right  
 leg fractured.  
 LWD: 30 days

At around 2 P.M., on Monday, February 27, Mr. H, an assistant carpenter, (65) was going to climb down a A-frame ladder after he finished his work. When his left foot reached to the 2nd step, he lost his balance. He jumped down on the right leg and plunged into his toolbox that was left on the floor in a disorderly manner.

He had the joint of his right leg fractured and could not work for 30 days.

- 1 Make thoughtful arrangements for aged workers.

(Reasonable assignment → Prohibition of work at high)

- 2 Organize and clean up toolboxes and materials. Keep the working area clean.

- 3 Don't stand on the top of a A-frame ladder when working.

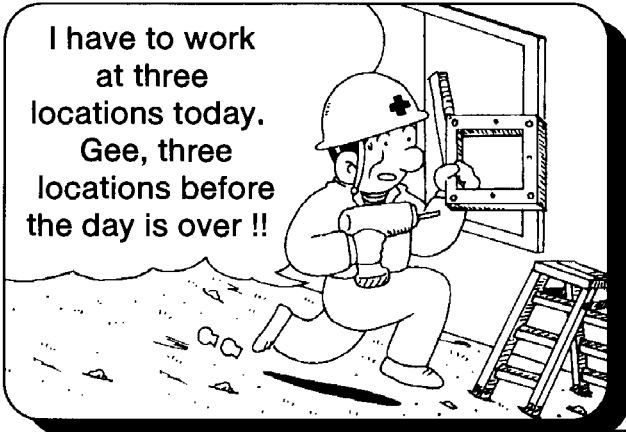
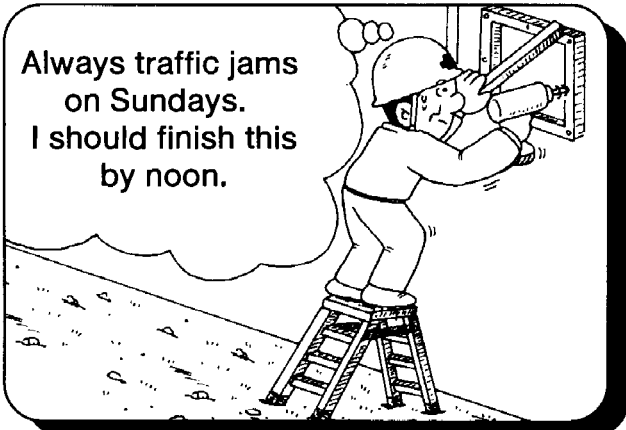
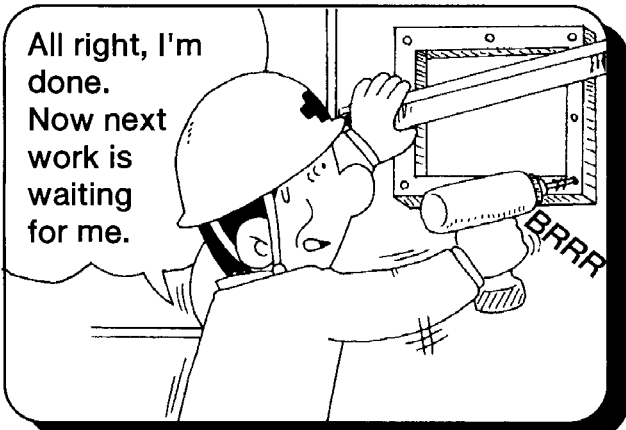
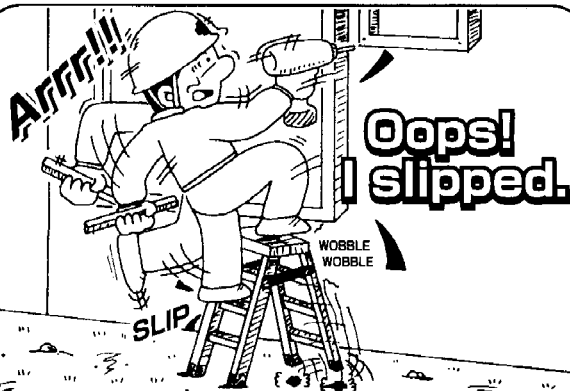
Why Me on Sunday?

Sunday, August 21

As the delivery date was at close hand, he worked even on the Sunday.

He just finished installing the outer frame of a ventilation hood. He was trying to climb down the A-frame ladder, holding a rechargeable screwdriver and materials in both hands.

He tripped on the A-frame ladder and fell down to the ground. He had his left heel bone fractured.

LWD: 90 days

Mr. G, a kitchen assembler with 33 years' experience, was working on Sunday as he had some 10 more orders which were yet to be completed in time for delivery during the summer vacation season. He finished installing the outer frame of a ventilation hood, and was climbing down the A-frame ladder with a rechargeable screwdriver and materials in his both hands. (Probably he was impatient for the remaining works.) He tripped on the A-frame ladder and fell down to the ground. He had his heel bone fractured and could not work for 90 days.

- ① Don't stand on the top of a A-frame ladder when working.
- ② Don't climb up and down with both hands full.
- ③ Slow down and keep patient. (Impatience invites disaster.)
- ④ Always try to predict potential hazards.

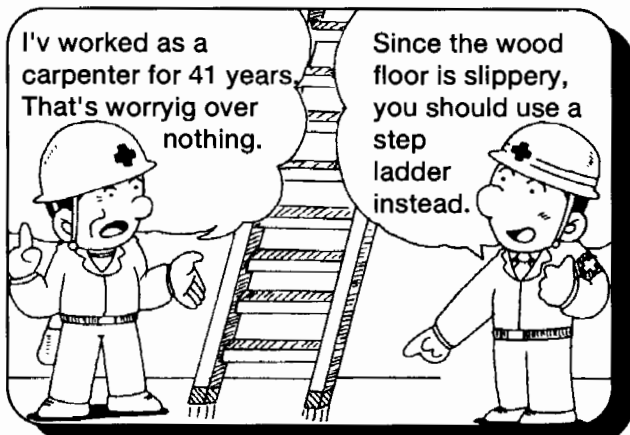
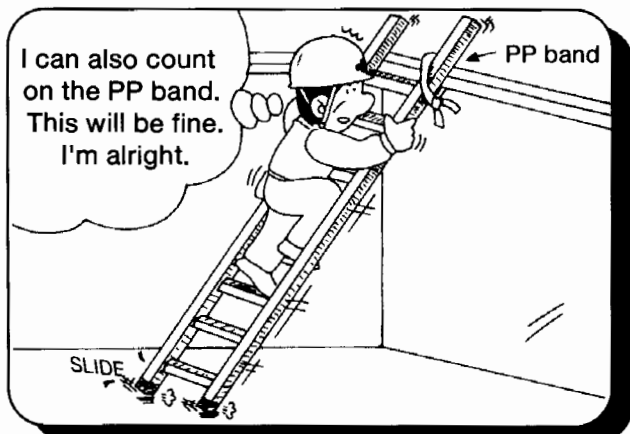
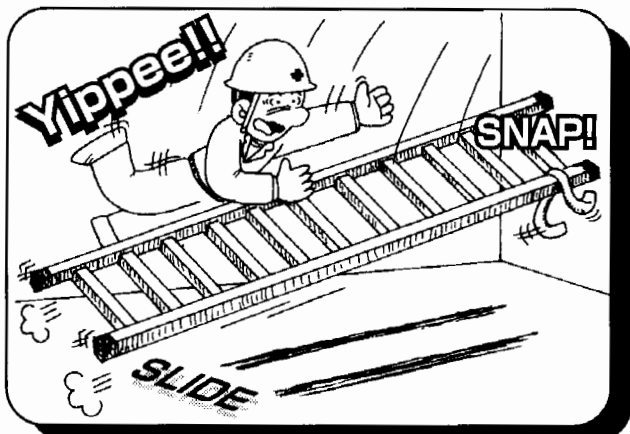
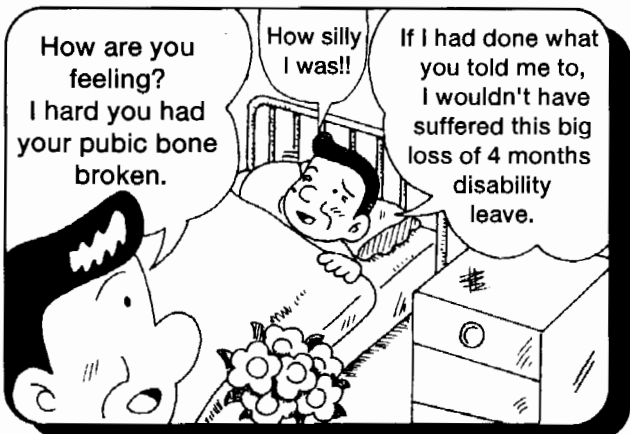
I Should Have Followed Boss' Instruction.

Thursday, May 25  
 At around 8:40 A.M..  
 Fine in weather  
 58 years old Carpenter  
 41years' experience

He turned down the suggestion.  
 The ladder was fastened with a PP band (packing belt).

The PP band was broken off and the foot of the ladder moved off to the side. He got thrown out of the ladder and fell down.

He had his right femoral bone, right pubic bone and ischial bone fractured.  
 LWD: 120 days

Mr. B, a carpenter, was scheduled to resume his work on the 2nd floor of a house. The ladder, which had been placed before, was not there because the flooring work on the 1st floor had been done on the day before. His supervisor recommended a step ladder for his work. Mr. B, however, turned him down, saying he couldn't be bothered and was all right with a simple ladder. He then set the ladder by himself which had been removed on the day before, and tied with a packing belt (PP band) to fix it. He got on his work.

At around 8:40 A.M., he began to climb the ladder to the 2nd floor. The ladder started slipping off to the side and the packing belt got broken off. He was thrown off the ladder and fell down to the floor.

He hit his right leg and hip hard against the floor and had his right femoral bone, right pubic bone and ischial bone fractured. He could not return to work for 120 days.

- ① Make sure that both the top and bottom of a ladder are fixed.
- ② Use a step ladder.
- ③ Provide guidance for paying constant attention to safe practices. (Don't put too much confidence in experience)

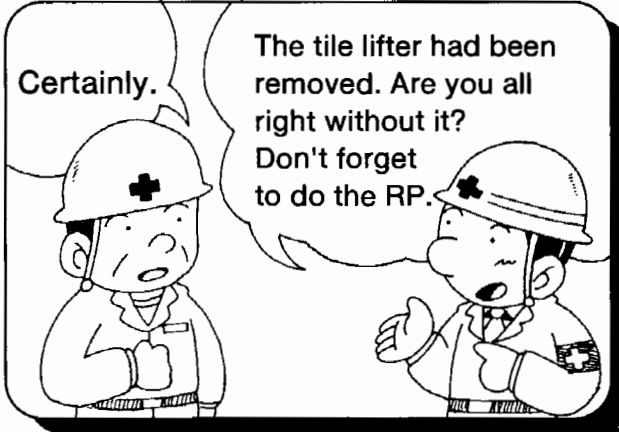
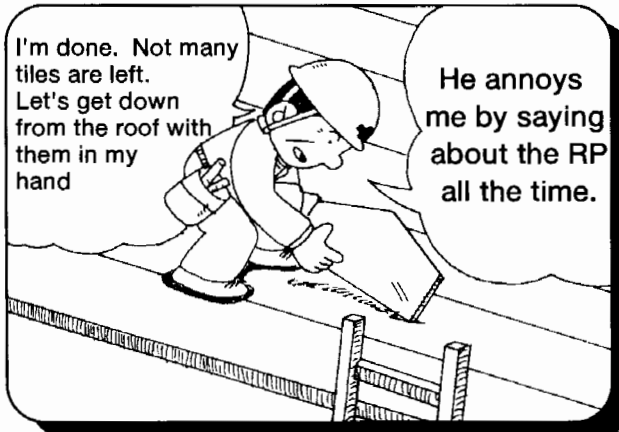
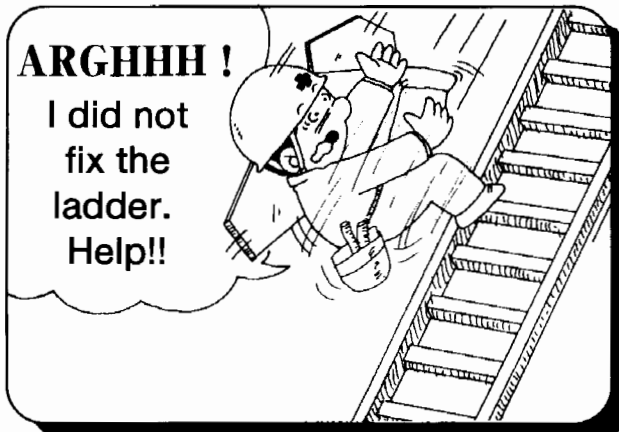
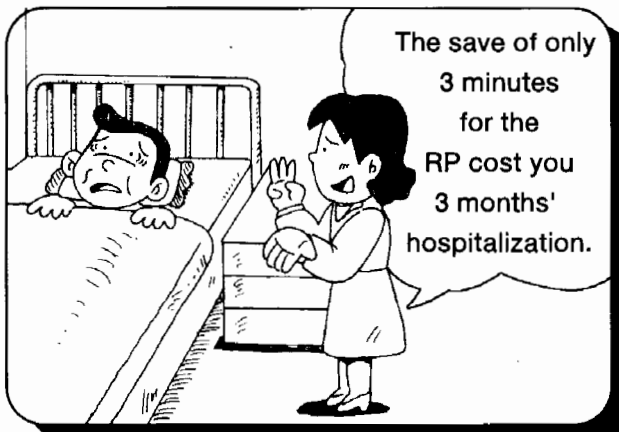
3 Minutes for RP Could Have Helped

Monday, March 7  
 At around 10:30 A.M.  
 Cloudy in weather  
 55 years old Roofer  
 25 years' experience

The ladder was not fixed.

The ladder wobbled, and he could not retain his balance because he held tiles in one hand.

He fell down to the ground. He had his right rib bone and right pelvis fractured.  
 LWD: 80 days

At around 10:30 A.M., on Monday, March 7 Mr. C, a roofer, set to work on laying tiles on the roof after he made a morning briefing with his supervisor. After he completed his work on the roof, he was going to climb down a ladder, holding the remaining tiles. (The tile lifter was removed already. He thought he could descend the ladder with the remaining tiles since they were not many and manageable in one hand.)

When he stepped onto the ladder, it wobbled because it was not fastened. He lost his balance and fell down to the ground.

He hit badly against the ground. He had his right rib bone and right pelvis fractured. It took him 80 days to return to work.

- ① Make sure that both the top and bottom of a ladder are fixed.
- ② Don't climb up and down a ladder with hand full.
- ③ Make RP before work. It is workers' responsibility to eliminate potential hazards. When they cannot handle by themselves, they should contact their supervisor. Don't start working before the improvement is confirmed.

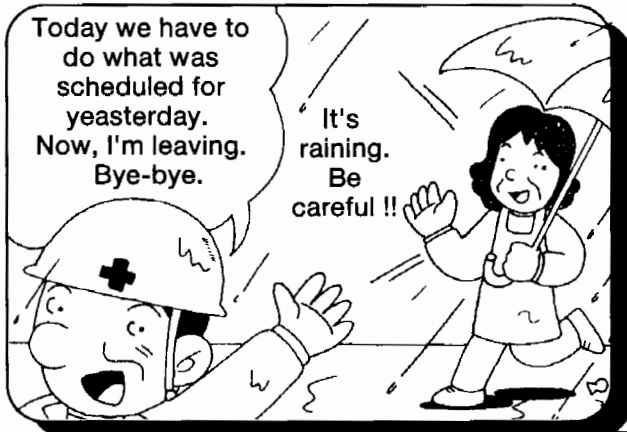
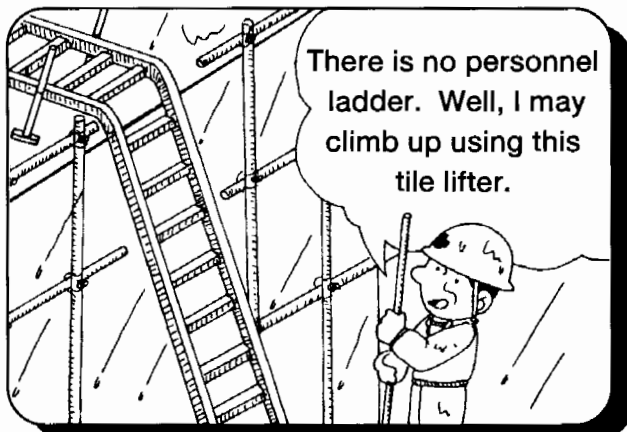
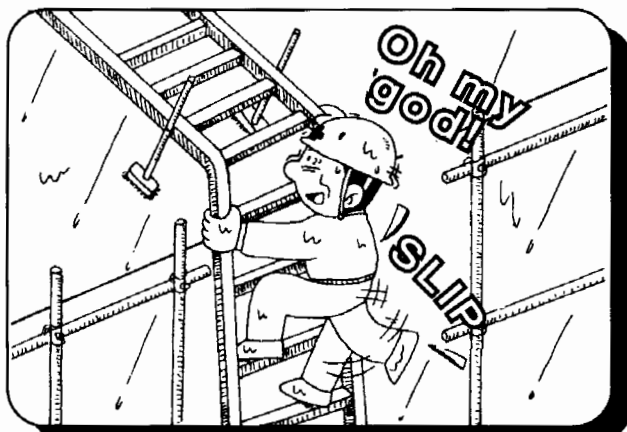
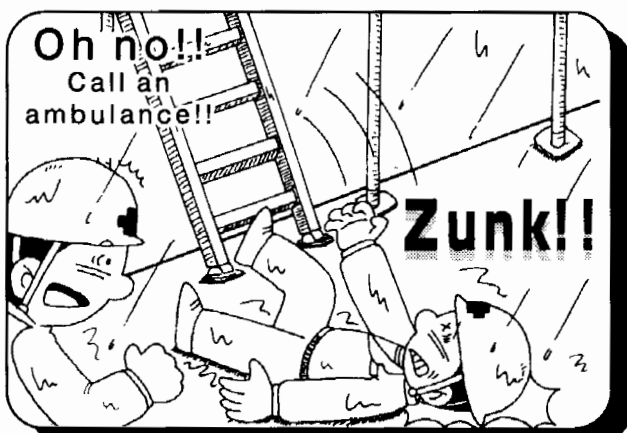
Just Needed A Personnel Ladder

Thursday, October 12  
 At around 10:35 A.M.  
 Light rain in weather  
 54 years old. Roofer  
 36 years' experience

Since a personnel ladder was not prepared, he substituted a tile lifter to climb up to the roof.

After he completed his work, he was going to get down from the roof, using the tile lifter.

The rain made the steps slippery, and . . . he slipped.

He fell down on the road. He had his skull broken and suffered brain contusion. He got into a critical condition and lay unconscious for a year and 2 months before he died.

He was installing a tile lifter on the scaffold to carry roofing materials up to the roof of a two-storied house. After he fixed the top of the lifter, he was going to climb down the tile lifter, as there was no personnel ladder installed on the scaffold. Unfortunately it was lightly raining. He slipped on the wet lifter and crashed on the ground.

He was brought to a hospital by ambulance. He had his skull broken and suffered brain contusion. He got into a critical condition and lay unconscious for 1 year and 2 months before he passed away.

- ① Operation at height is suspended when the footing is wet, even if it is drizzling.
- ② Install an personnel ladder
- ③ Document operation procedure and put it in practice.
- ④ Make RP

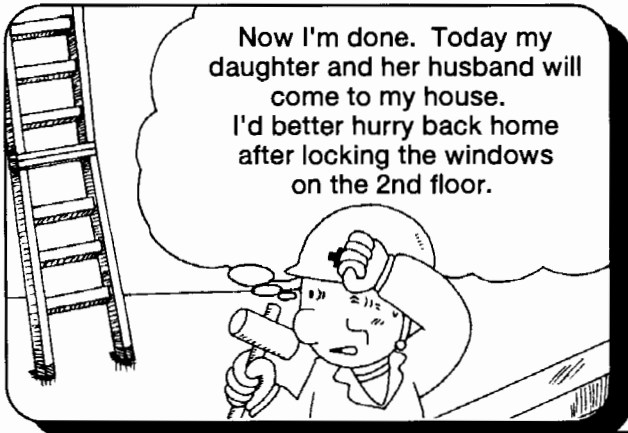
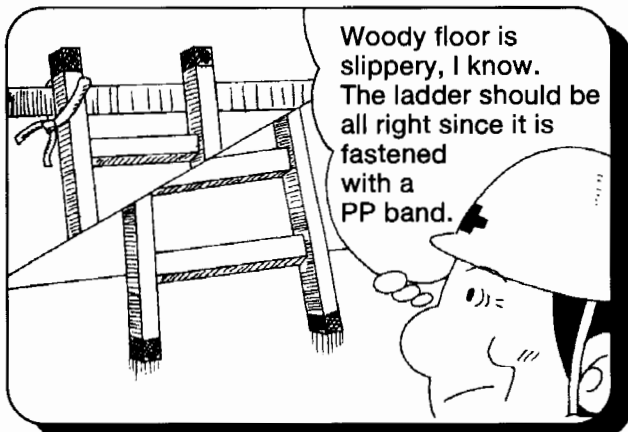
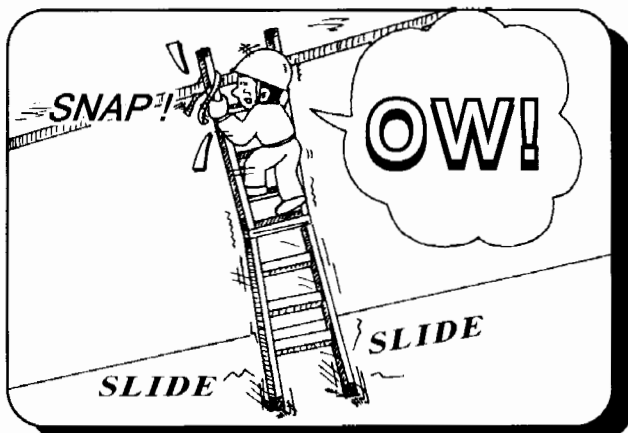
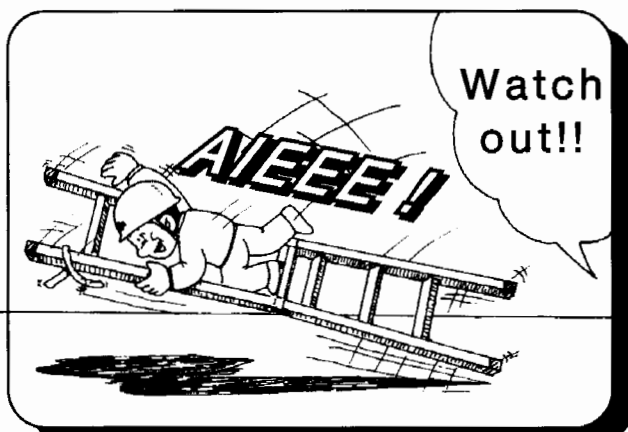
No A-frame ladder Can Be Substituted

Saturday, November 4  
 At around 5:25 P.M.  
 Fine in weather  
 57 years old Carpenter  
 2 years and 11 months' experience

The top of the ladder was fixed with a PP band (packing belt). The rain made the steps slippery, and . . . he slipped.

The A-frame ladder was substituted for a ladder. The PP band was broken off and the A-frame ladder started moving off to the side.

He fell down together with the A-frame ladder. He had his thumbs and rib fractured.  
 LWD: 50 days

Mr. A, a carpenter, finished his interior work for the day and was preparing for leaving the construction site of a two-storied house. His daughter and her husband were supposed to come to his house in the evening. He hurried up to the 2nd floor to lock the windows. When he came to the 6th step, the legs of the A-frame ladder started sliding off the side. It was unstable because the A-frame ladder was used as a ladder. The floor was woody and slippery. The PP band with which the A-frame ladder was fixed at the top was broken off. He pitched forward together with the A-frame ladder. He badly hit his both hands and chest and had his thumbs and a rib fractured. It took him 50 days to return to work.

- ① Always carry out safety practices. Proactively participate in safety training.
- ② Use a proper ladder or step ladder.
- ③ Make sure that both ends of a ladder are fixed.  
(with ropes, rubber bands or bolts)
